Wiping Pin-Socket Contacts

Removing The Command Station MicroProcessor From 68 pin PLCC Socket

CVP PRODUCTS

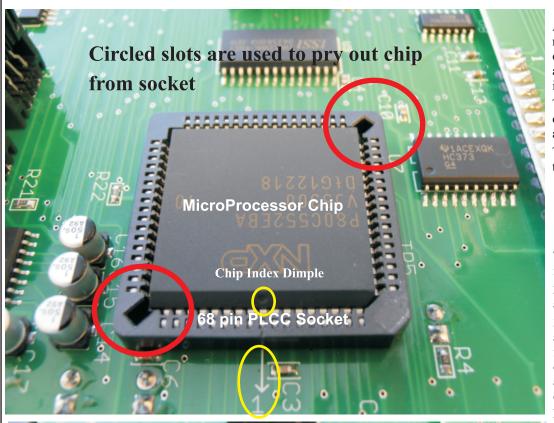
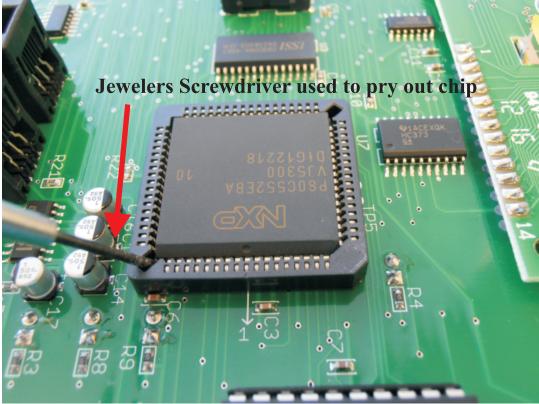
- 1. Locate the largest chip on the board. This will be the microprocessor plugged into its 68 pin socket.
- 2. Observe the orientation of the socket and chip.

- 3. Locate the index mark for both the chip and socket. For the chip, it will be a dimple in the center of one side (small yellow ellipse. For the socket, pin 1 is labeled with an arrow and a big numeral 1 (big yellow elipse). Remember this orientation since plugging the chip in differently will damage the socket, the chip or both.

- 4. Look at the 4 corners of the socket. Notice that two corners have holes visibly different than the other two corners of the socket. These two holes are circled in red. Note that your socket may look a little different but it will be similar in construction. These two holes are used to remove the chip from the socket.

- 5. Use a jewelers screwdriver to gently remove the chip. Take care not to crack the thin fragile corner of the socket. Alternately pry up on each corner a little at a time. Eventually the chip will come out.

DO NOT USE XACTO KNIFE BLADE! Either side of the thin blade will easily crack the socket.

6. Once the chip is out, carefully re-insert it. Orient it in the same position as when removed. Place it squarely on top of the socket. Push down on the chip equally on all sides until it is seated back into the socket.
